Inspection Report

HomeGuard
Inspection Services

Property Address

11265 Albion Circle, Thornton Co 80233

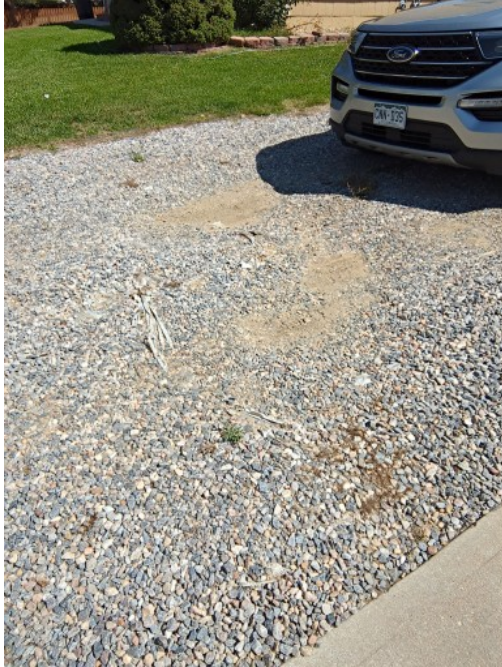
1.2) Driveway Conditions

Gravel parking area shows evidence of ponding. It is suggested that a "Licensed Landscaping Contractor" be contacted for further evaluation and repair.

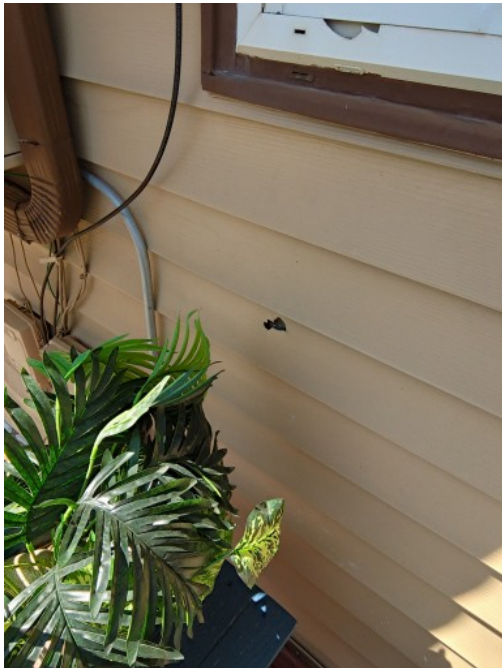
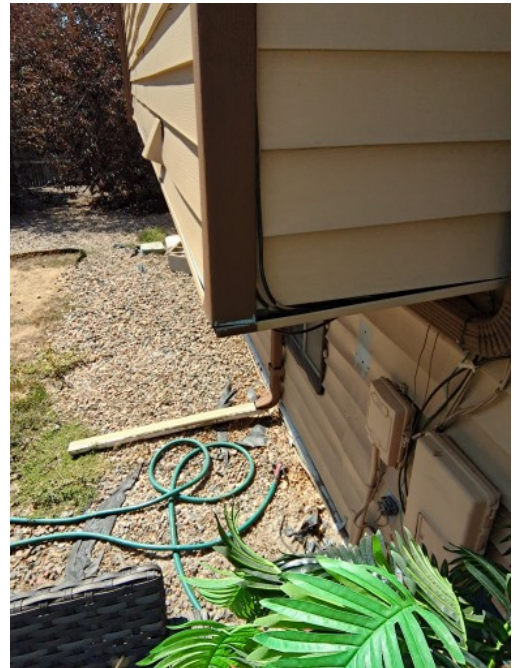
Exterior Walls

Structure Type Vinyl siding is damaged in some areas Safety. Recommend repairs as needed.

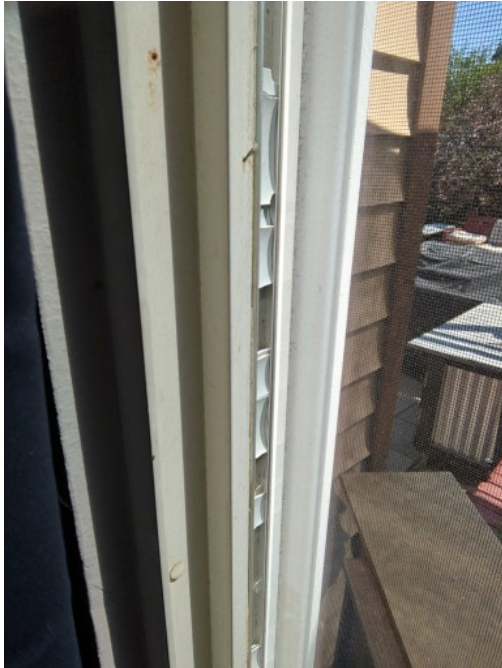
2.4) Window Conditions AS

The thermal pane window(s) appear to have lost its / their thermal seal. Moisture, fogging, and hazing are common signs of this condition. While mostly cosmetic, this condition is generally not repairable. Correction would require replacement of the window(s) or window pane(s). Sliding door in back of home

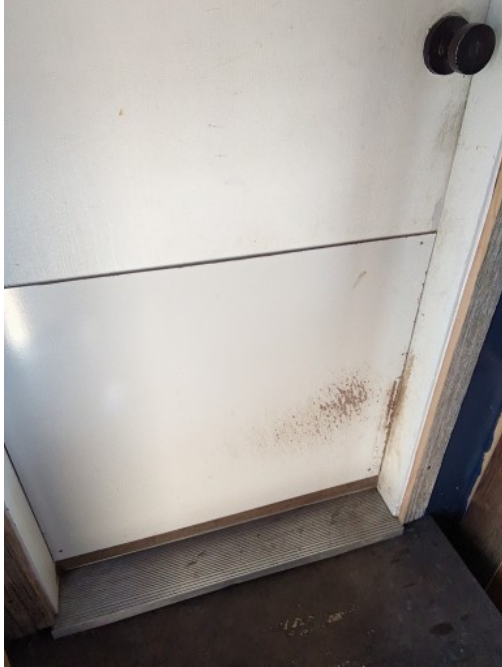
2.5) Exterior Door Conditions AS

Pet related scratching / damage was observed at door(s). Garage entrance

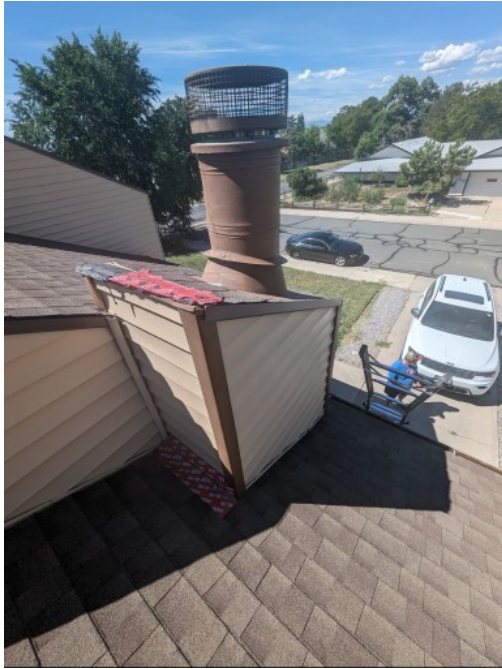
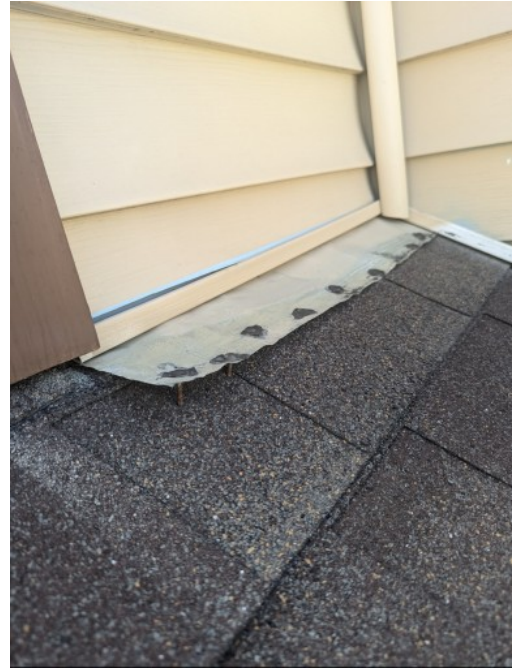
2.7) Chimney Conditions

Sealing is needed between the chimney and the wall. Water penetration may have occurred. Further evaluation would require the removal of siding, which is not performed as part of our inspection.

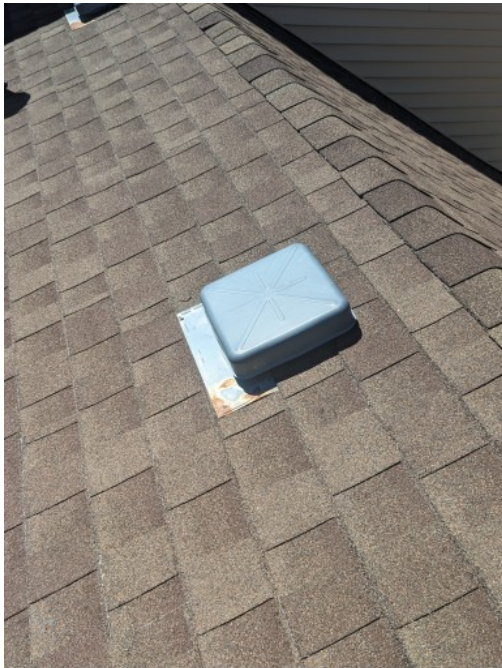
Roof Covering Material

Gable roof appears in good condition

Asphalt composition shingles

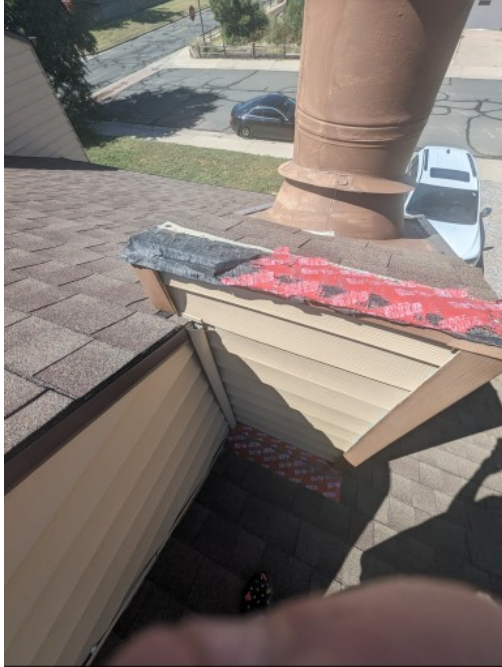
3.2) Flashing Conditions

Flashings appeared to be improperly installed at the chimney. It is suggested that a "Licensed Roofing Contractor" be contacted for further evaluation and repair. .

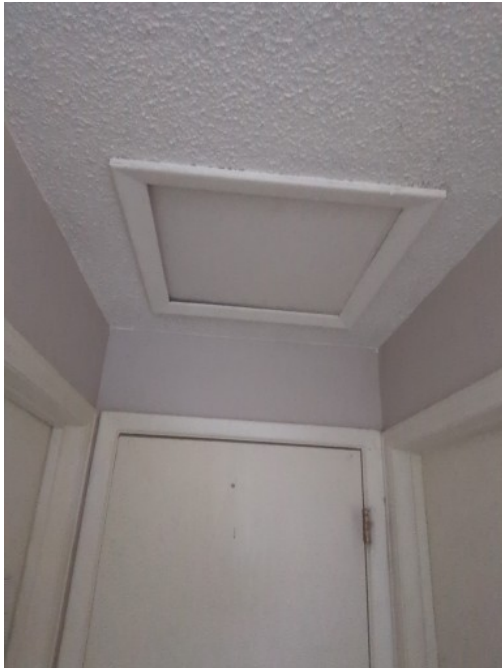
Attic Access

Attic access found in hallway on upper floor Appears Serviceable.

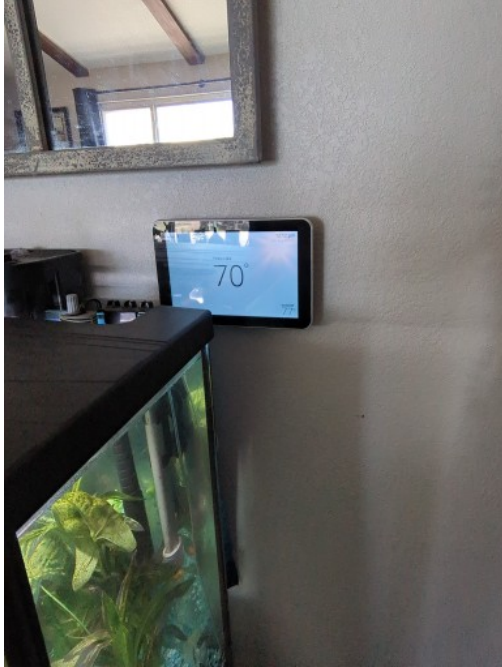
4.4) Thermostat Condition

The normal operating controls appeared to be in normal working order at the time of inspection. Located in living room

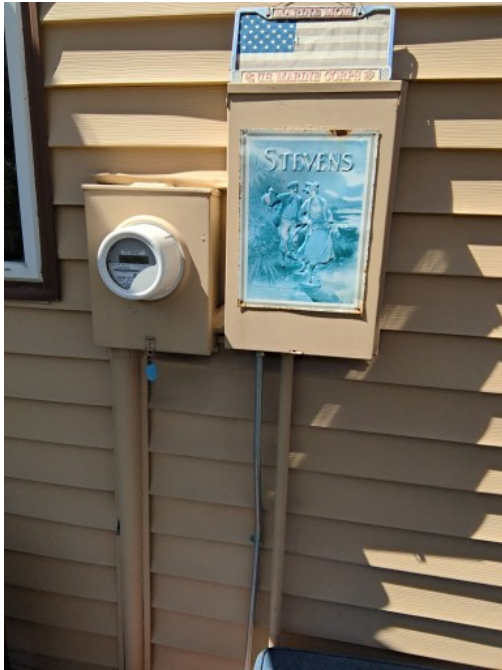
Electric Panel Location

The main electric panel is located at the exterior near rear sliding door

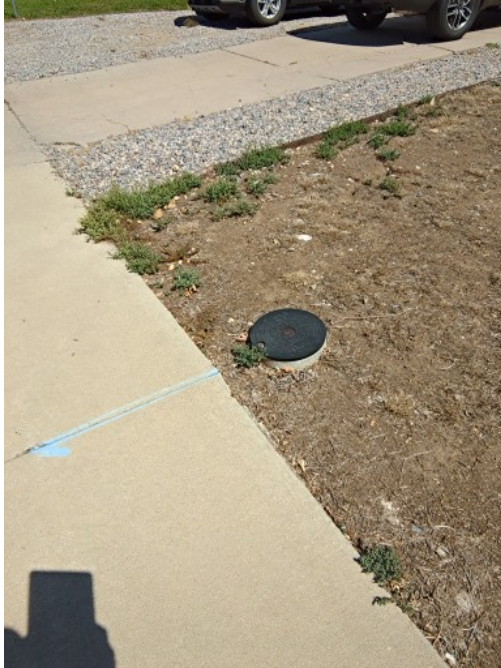
Main Shutoff Location

The main valve is located at the street next to driveway and sidewalk

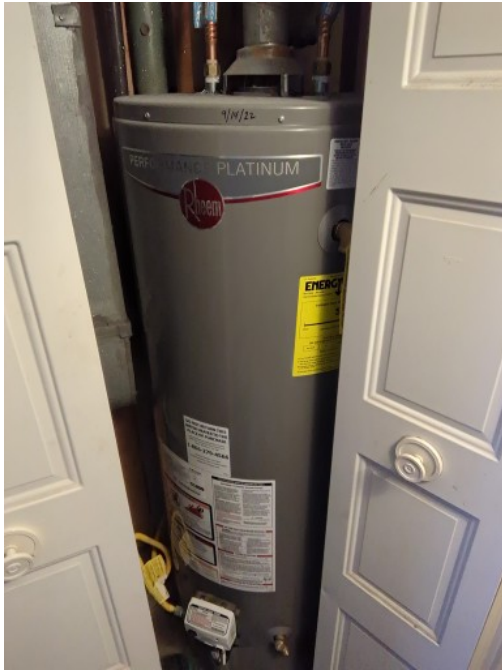
Water Heater(s)

Water Heater Type Natural Gas.
Water Heater Location Basement.
Water Heater Capacity 50 Gallon. Installed 09/14/2022

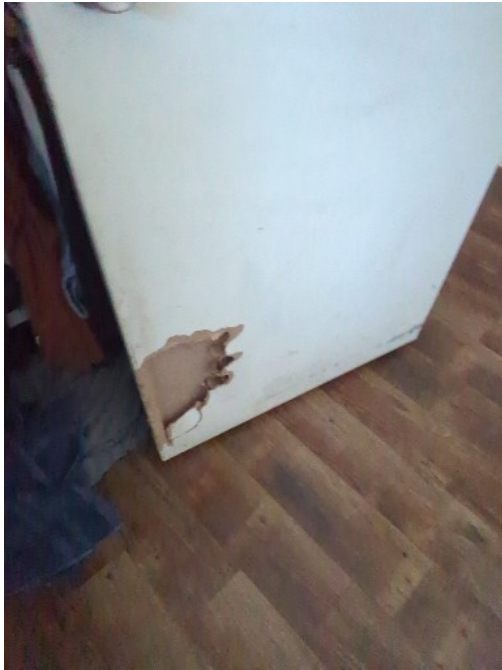
7.6) Interior Door Conditions

Pet related scratching / damage was observed at doors on upper level

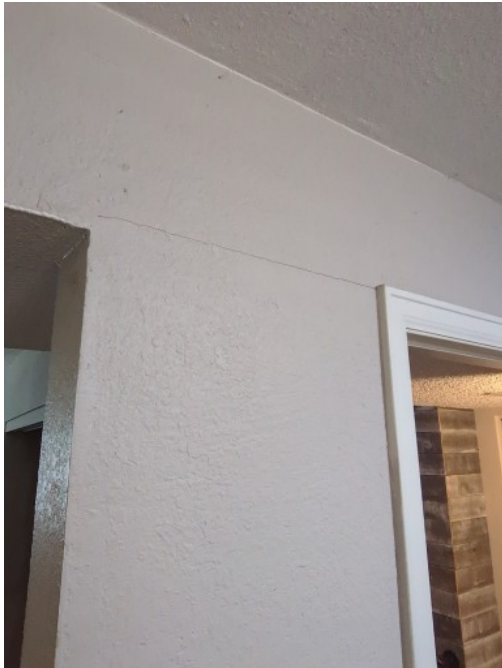
8 Bedroom 1**Walls - Ceilings - Floors****8.1) Wall Conditions**

There were common settlement type cracks and nail pops observed to the interior walls. Although these conditions are common in most homes, client is advised to monitor cracks for future movement. Located in basement

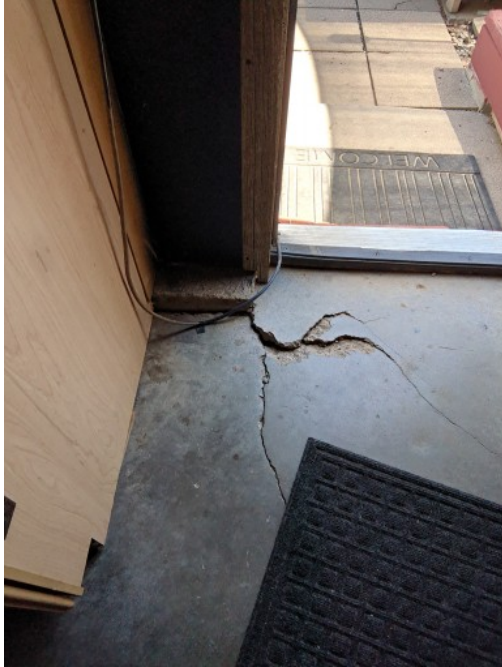
17.5) Floor Conditions

Substantial floor sloping was observed at . Recommend further evaluation by a qualified / licensed contractor. Cracks and settlement were observed to the concrete flooring. Recommend further evaluation by a masonry contractor.
